SUBJECT/PROJECT: Guadalupe Recycling and Disposal Facility
San Jose, California, 95120

Re: Oak Tree Mitigation Monitoring Report

**GUADALUPE RECYCLING & DISPOSAL FACILITY
OAK TREE REPLANTING PROJECT
MITIGATION MONITORING REPORT**

DECEMBER 2011

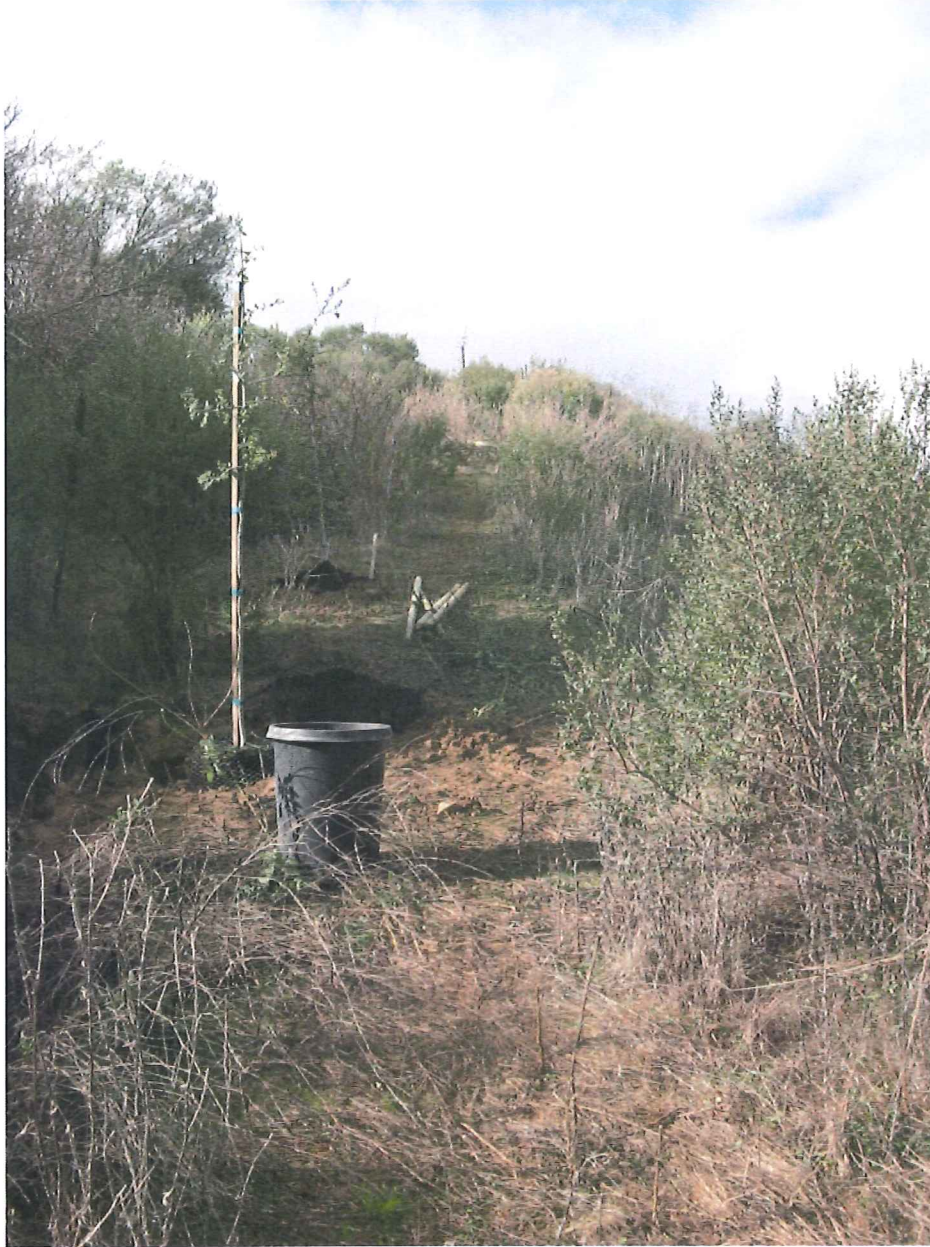
TYPICAL PLANTING BEFORE TREE PROTECTION DECEMBER 2010

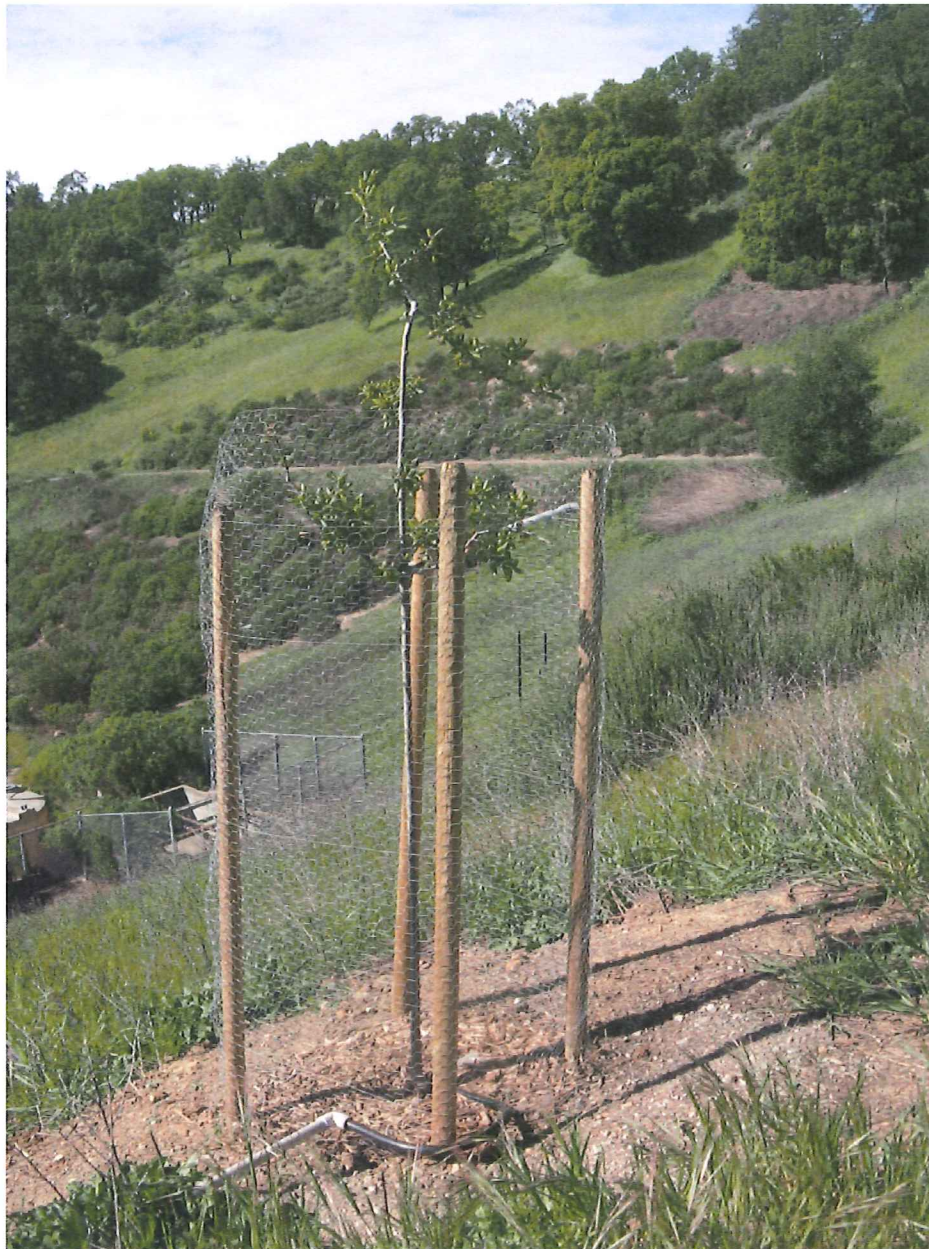
TREE PLANTING DETAIL WITH TREE PROTECTION AND IRRIGATION APRIL 2011

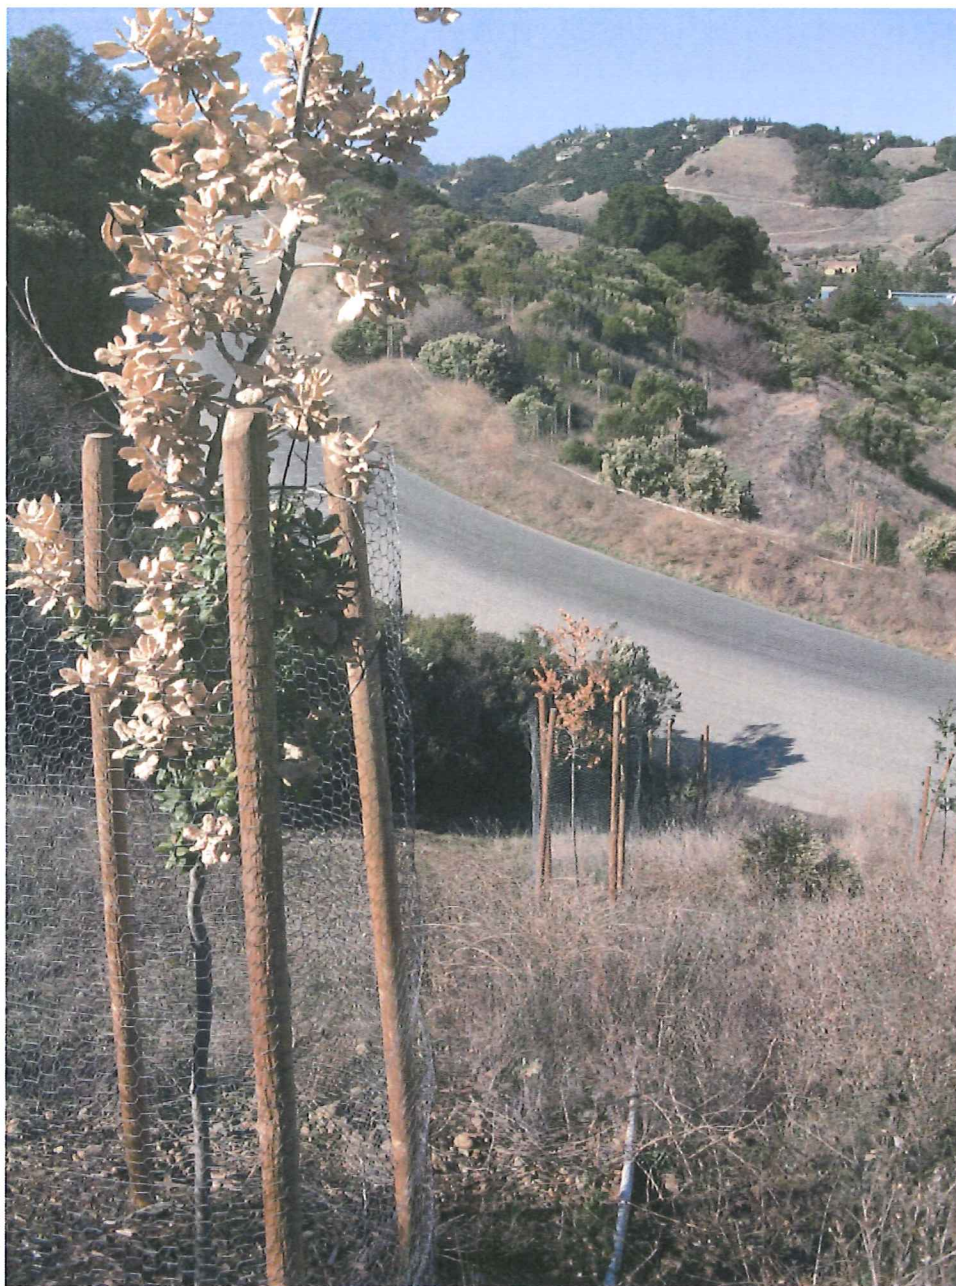
Monitoring for tree condition was done in April 2011 and November 2011. In April all of the trees were found to be alive and the tree protection and irrigation system intact. In November, eight of the 5-gallon trees were found to be dead and four of the 15-gallon trees were found to be dead, for a total of 12 dead trees. Another five trees looked in questionable health and will continue to be monitored. GRDF directed the landscape contractor to replace 15 of the trees; two others will continue to be monitored. Tree replacement is underway as of the date of this report. The tree protection and irrigation systems were intact in November and no evidence of predation was found. Monitoring will continue in April and November 2012 to confirm that all of the trees have become established.

*TREE IN FOREGROUND STILL SURVIVING; TREE IN CENTER IS DEAD;
TREE ON RIGHT IS HEALTHY, NOVEMBER 2011*
